Addendum P05 2019.07.22 Structural Engineer Report

22 July 2019

Ref: 10152

House Fitchat-Visual Structural Inspection 91 Frangipani Street Kleinbron Estate

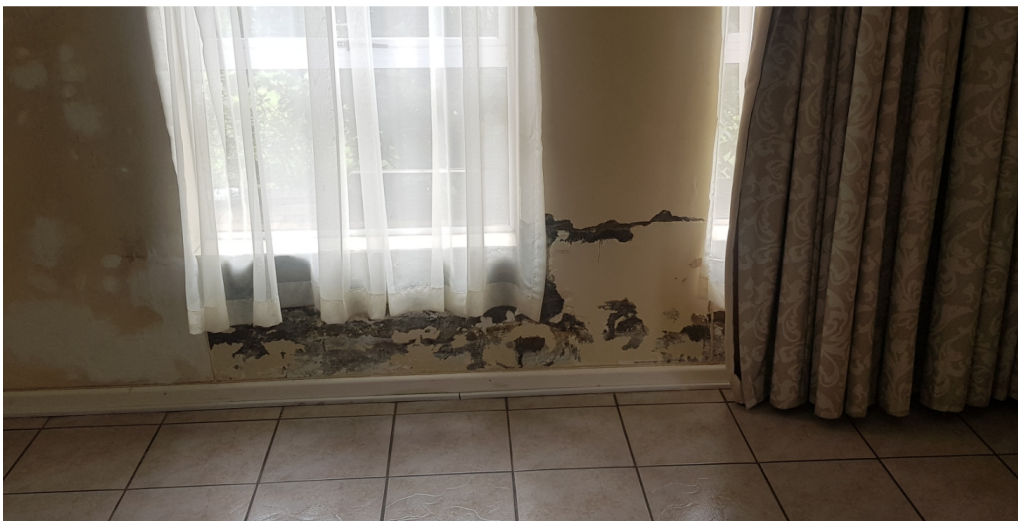
Various instances of water damage are visible throughout the property, both internal and external. The water damage is widespread, increasing in severity at the northern/eastern elevations of the property.

Photograph 1 – Northern Elevation Lounge area internal wall damage

The water damage appears to mostly near bottom of the walls and above lintol level. Indicating on rising damp/non-functional weep holes and or absence of damp-proof membrane at window level/floor level.

The water damage cause must be addressed before any repairs are done. A reputable water proofing specialist should be consulted with regards to products and methods. The water damage to the walls points to an underlying issue with regards to the wall construction, damp proof course not installed correctly, weep holes not performing in draining of the cavity or cavities bridged (not clean).

It must be noted that this defect would have been an historic issue and will return during wet seasons if not treated correctly.

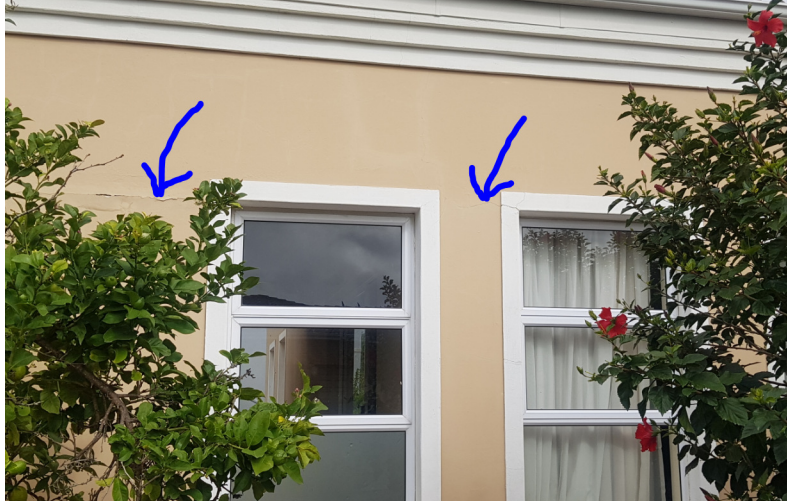
Photograph 2 - External view of Northern Lounge wall, note damage at window lintol level

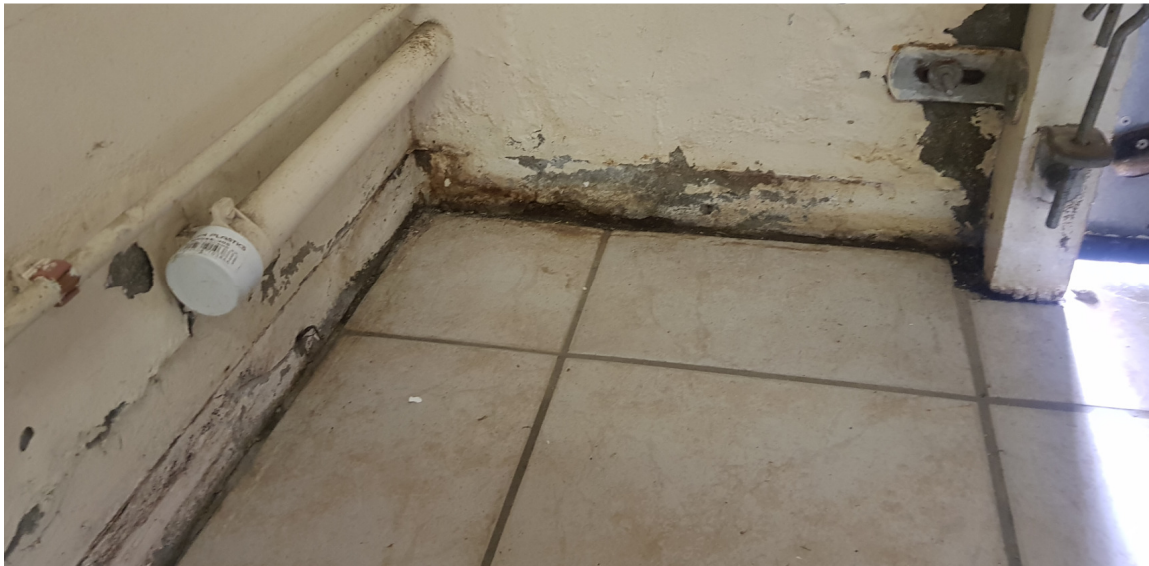
Photograph 3 - Garage wall, adjacent to bathroom

In addition to the above, it appears that there might be leakages from the plumbing as the internal walls are also water damaged in areas. This is visible at the garage. (See photograph 3)

Leak detection services would be required to establish if there are damaged pipes that contributes to the moisture/dampness of the internal walls. All waterproofing work must be done strictly to the specialist instructions and guarantee on workmanship and products must be obtained.

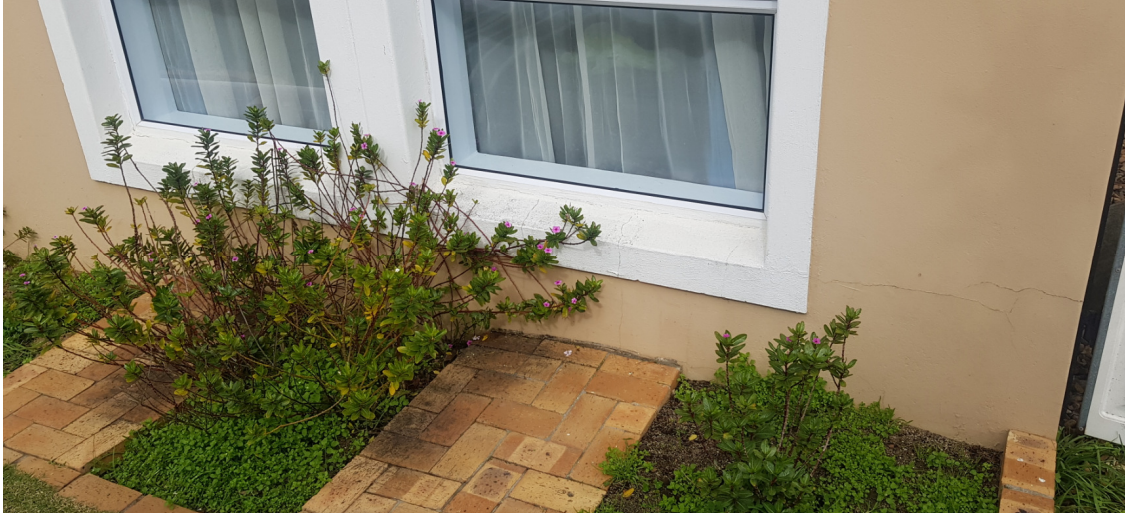
Photograph 4 - No Weepholes to external wall

In some areas it was noted that the weepholes were either omitted or covered with landscaping. (see photograph 4)

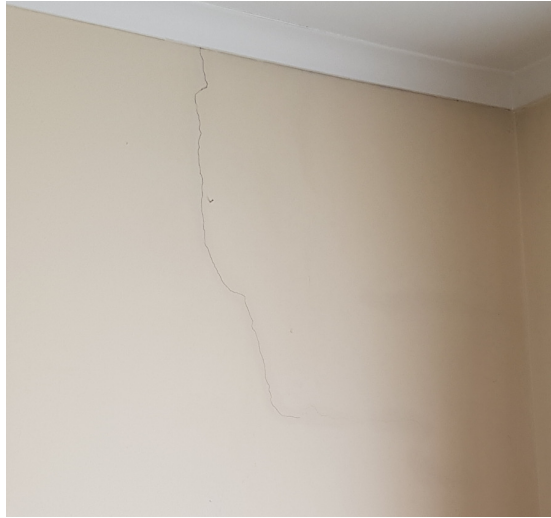
There are various widespread instances of cracking visible at the property. The table below (SANS 10400 – Part B) classifies damage to single storey masonry walls. Since the cracks are widespread throughout the building, it would be classified at Category 2.

Photograph 5 - Example of typical cracks observed (1-2mm)

The cracks that were visible during the inspection and mentioned in this report under above heading are mostly superficial and expected movement/settlement cracks. These cracks are not new and would have formed over the building life, starting soon after construction. The property does not pose a risk of structural collapse.

The recommended remedial action would be to repair these cracks after the water damages are repaired. The cracks need to be exposed and cleaned out at least 100mm in width. The masonry is to be treated with a bonding key and plastered. A fibre mesh should be installed over the cracks before plastered. It is advised that the cracks are repaired by a reputable contractor. It is advised that a good quality flexible paint is used over the repaired cracks.

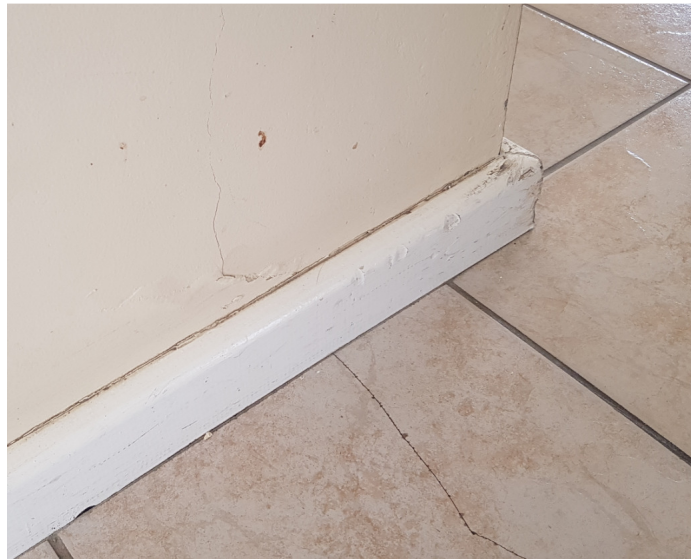
Photograph 6 – Example of cracks observed

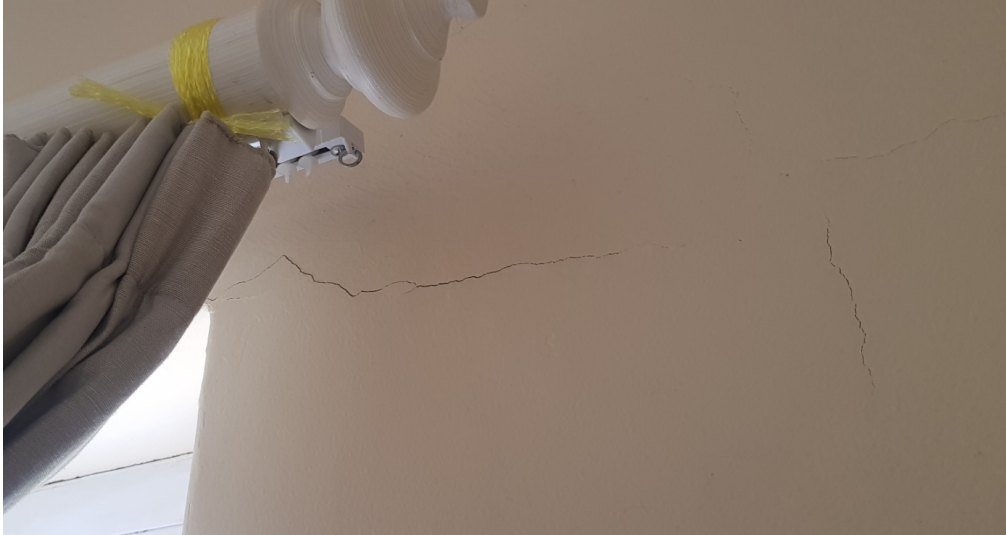
Photograph 7 - Example of cracks observed

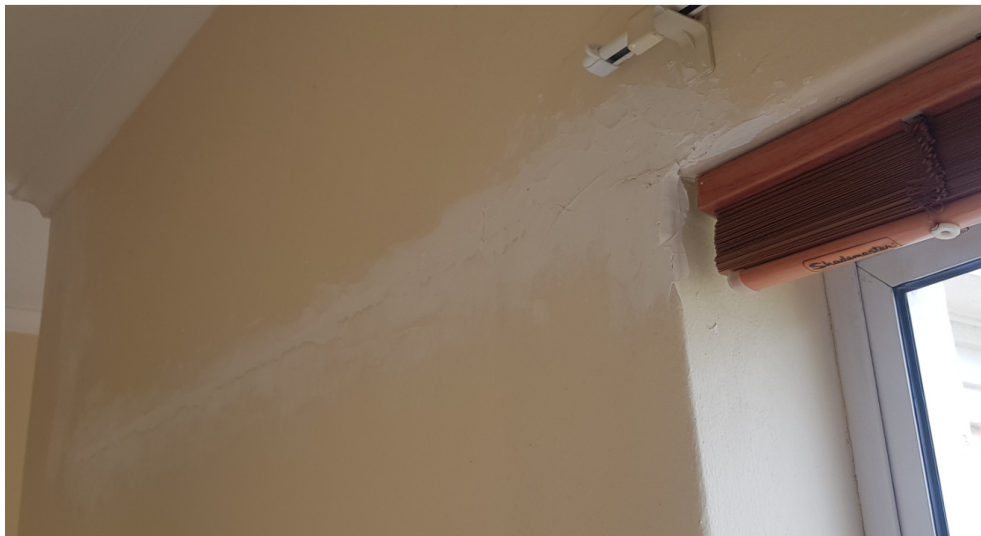
Photograph 8 - Repair work to typical cracks

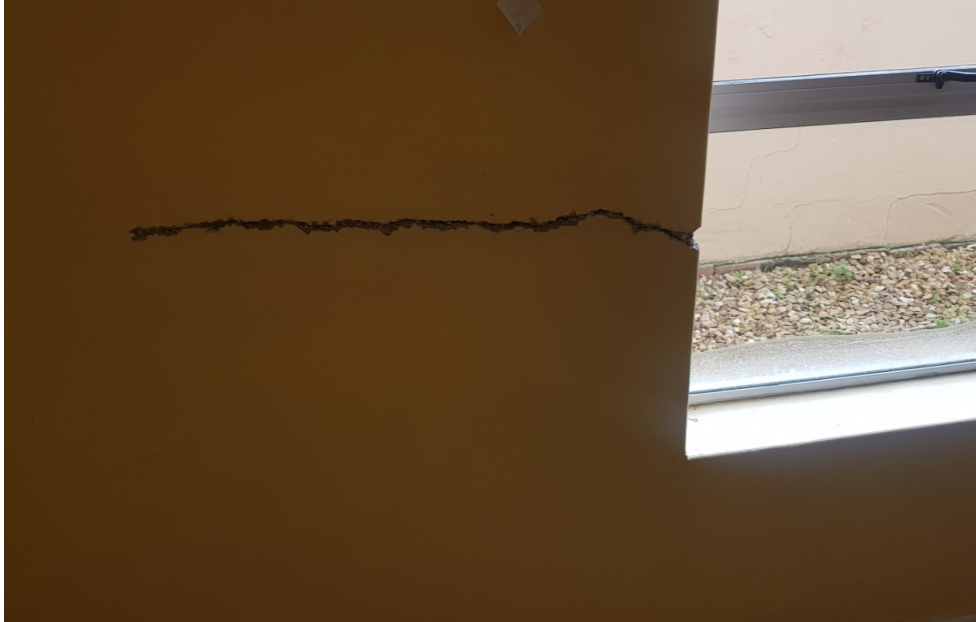
Photograph 9 - Repair work to cracks

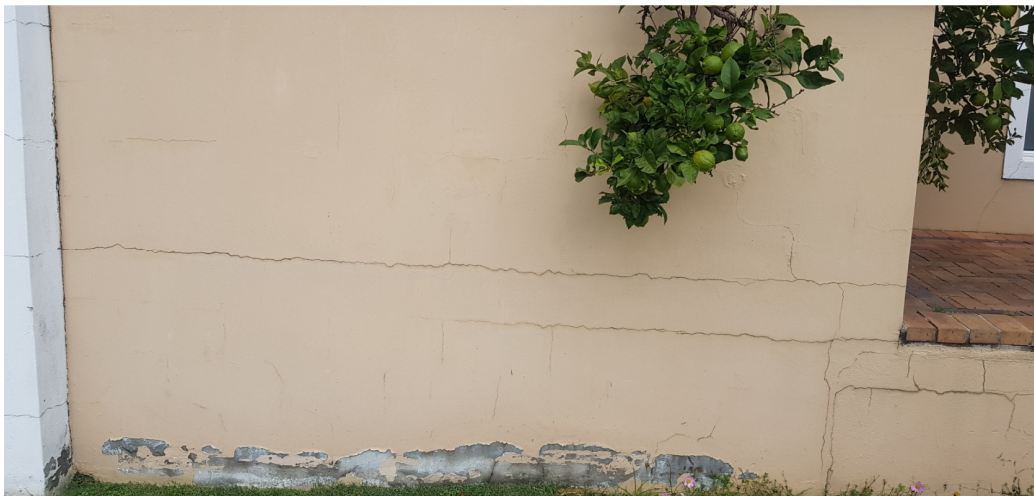
Photograph 10 - Typical external wall cracks

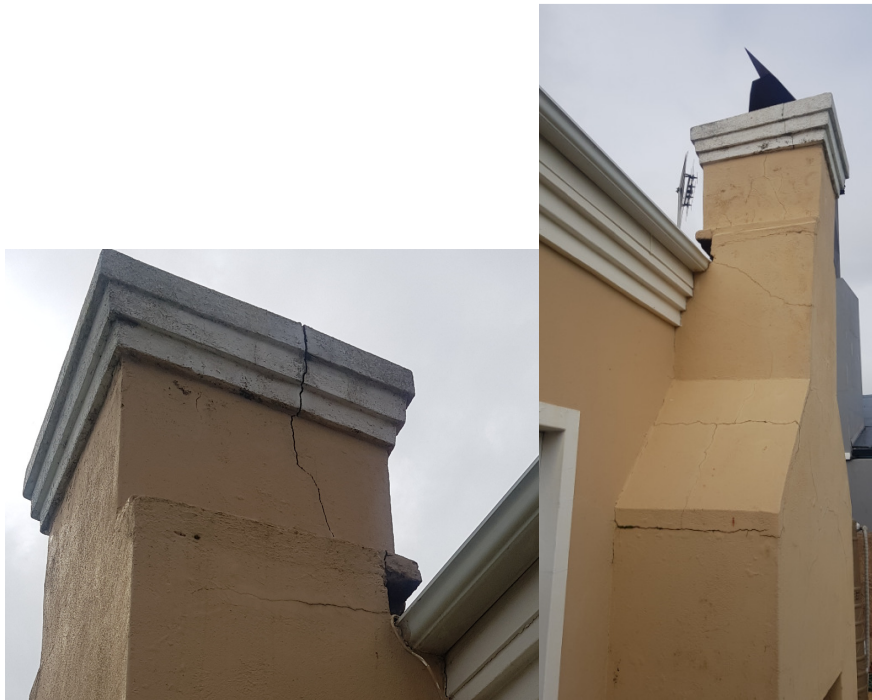
The chimney appears to be severely cracked near the top, it appears to be stable, but further deterioration could lead to dislodged parts. See photograph 11 below

Photograph 11 - Masonry Chimney

The damage to the top section of the chimney can be repaired by carefully breaking out the loose sections and rebuilding. The new masonry must be bonded to the existing section by interlocking with the existing brickwork.

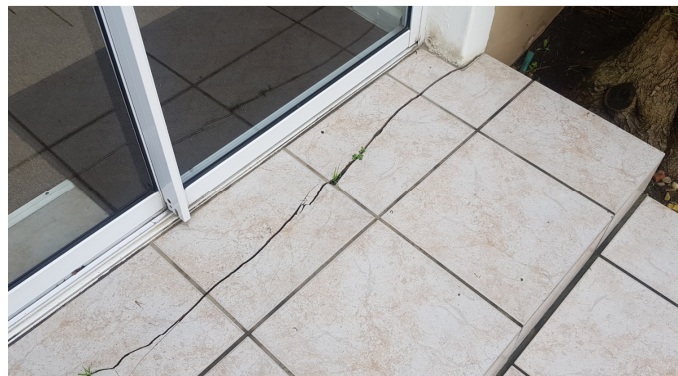
The steps leading from bedrooms to courtyard is cracked (+5mm) wide crack. This is due to uneven settlement between building and stair. This crack is open to water penetration and could worsen over time.

Photograph 12 - Settlement at steps leading from bedroom

The crack at the steps leading from the bedroom needs to be filled with a flowable non-shrink structural repair grout and re-tiled.
