IN THE MAGISTRATE'S COURT FOR THE DISTRICT OF **KUILS RIVER**

Case No: 863/2020

No. 43 - Notice to Third Party

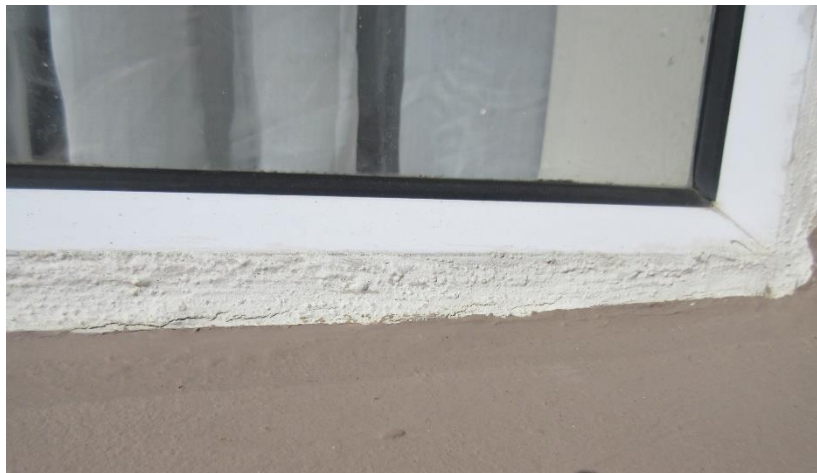
- The white epoxy coated aluminium windows have not been sealed around with a suitable flexible sealant but instead, seem to have been sealed with some sort of relatively non-flexible white material smeared over the window frames and appears to be containing sand. [Refer to photograph below]

Evidence of some sort of white emulsion containing sand or some granular material, partially applied over the white epoxy powder coated aluminium window frames, instead of a suitable flexible sealant.

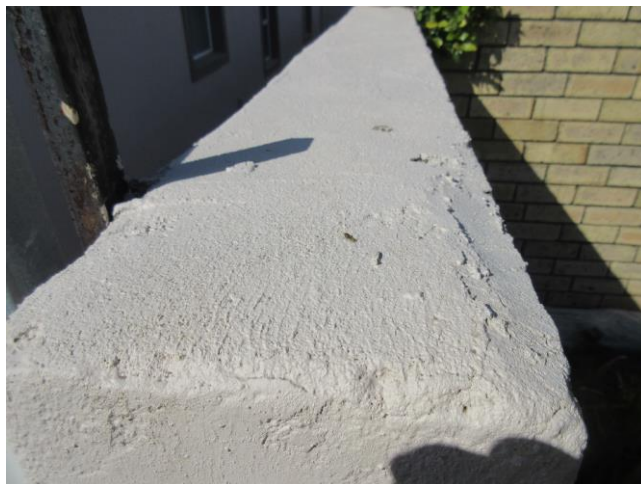
- This wall was constructed out of hollow concrete blocks which apparently were previously open on the top. This has now been filled and plastered over in a very amateurish way with no evidence of any membrane or waterproofing material having been applied over the top. [Refer to photographs below]

This wall has not been finished off properly on top and there is no visible evidence of any waterproof membrane on its surface.

3. That the exposed tops of all boundary walls should be properly plastered to a slope, neatly finished off and weather-proofed on top with a suitable acrylic membrane and acrylic waterproofing system. This should include making good all arris rounded plaster work which is currently defective.

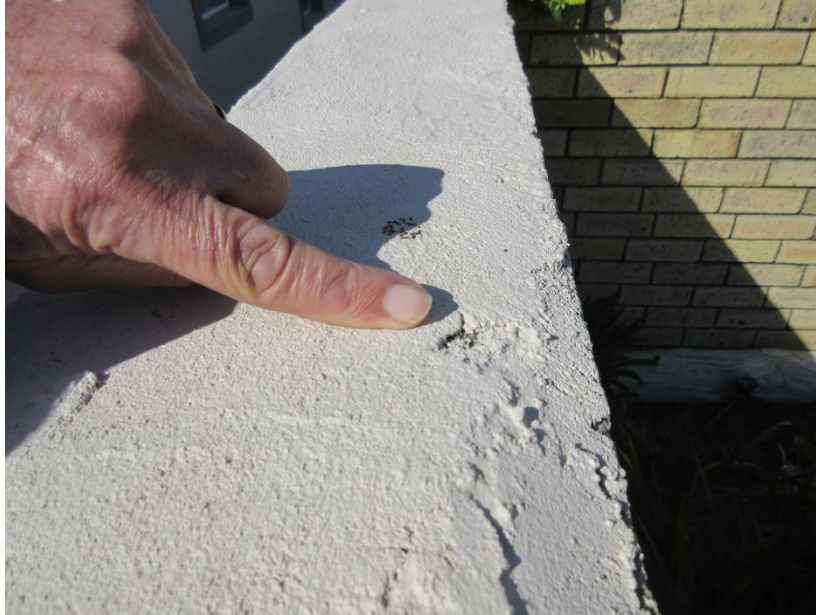
Evidence of very poor quality workmanship on top of this wall.

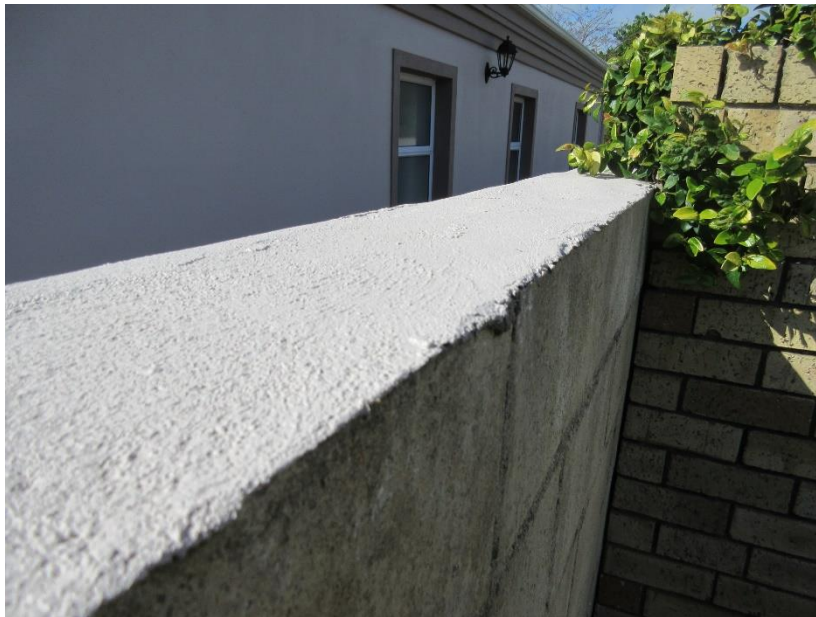
- It would also have been preferable, had this been plastered to a slope, so that water does not accumulate on the upper surface.

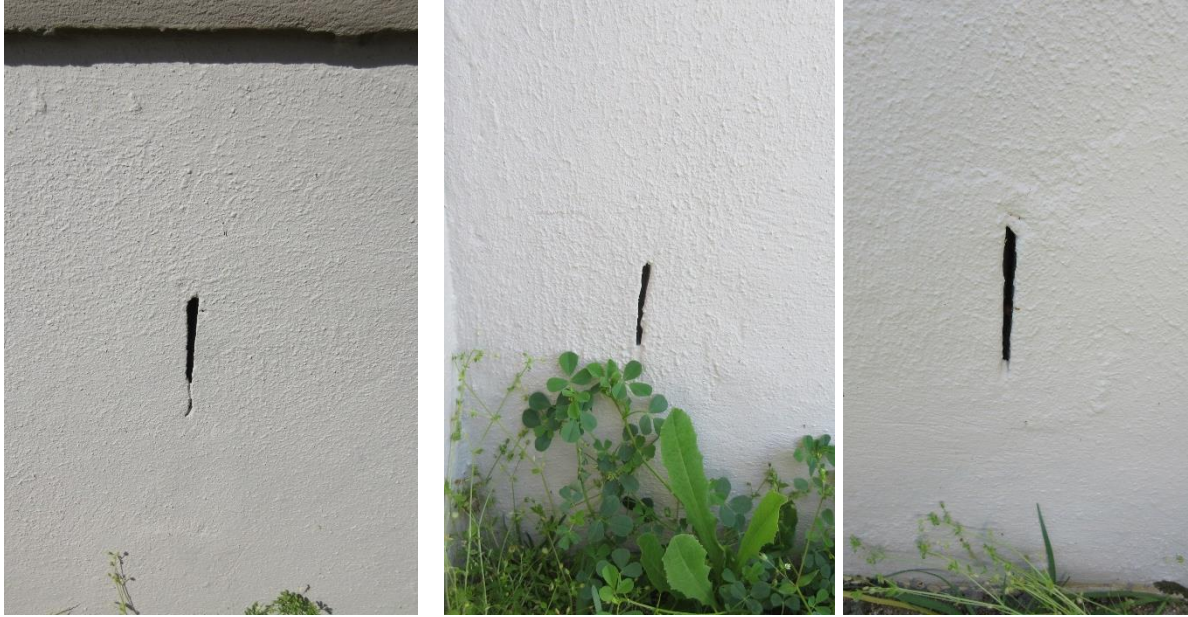
- On the front elevation of the house, being the North East elevation, weep holes were inserted long after the house was built. These are not plumb, not uniform in width and are poorly done. [Refer to photographs overleaf]

**Three separate weep holes in the same wall.
Note how they vary in width and height and the middle one is not even plumb.**

4. That all weep holes be modified so that they are all consistent in width and height.
5. That all cracks in the external walls be raked open to form a "V". These cracks to be properly filled with a suitable flexible sealant which must be allowed to cure and dry prior to painting thereover.

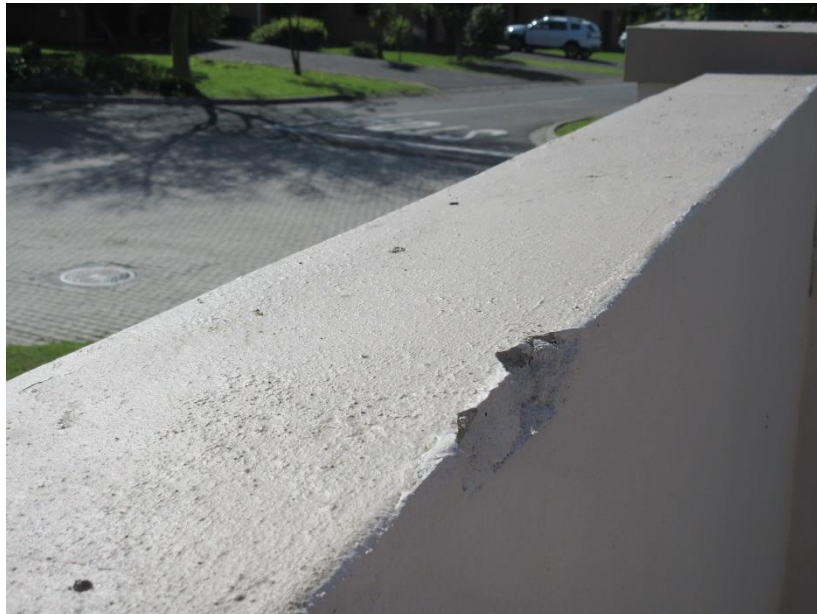
- This wall was also supposed to be waterproofed on top with a waterproof membrane of which there is no visible evidence and the wall has not been properly treated or coated. [Refer to photograph below]

This damaged wall has simply been painted over.

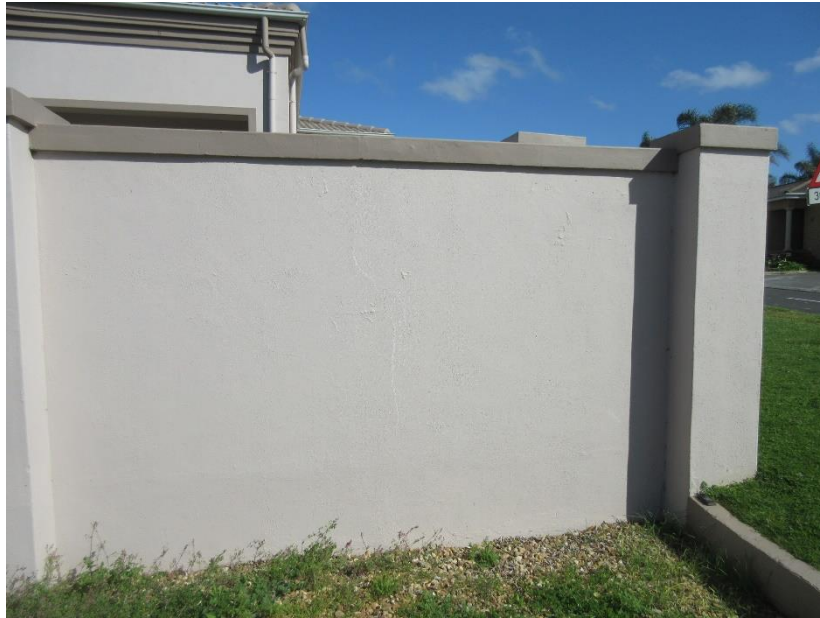
- This wall has been completed however, one can see evidence of moisture in the wall where the paint is now bubbling, flaking and delaminating from the substrate. Also, there is evidence of lime leeching out from a crack in the wall, which has not been properly fixed. [Refer to photograph below].

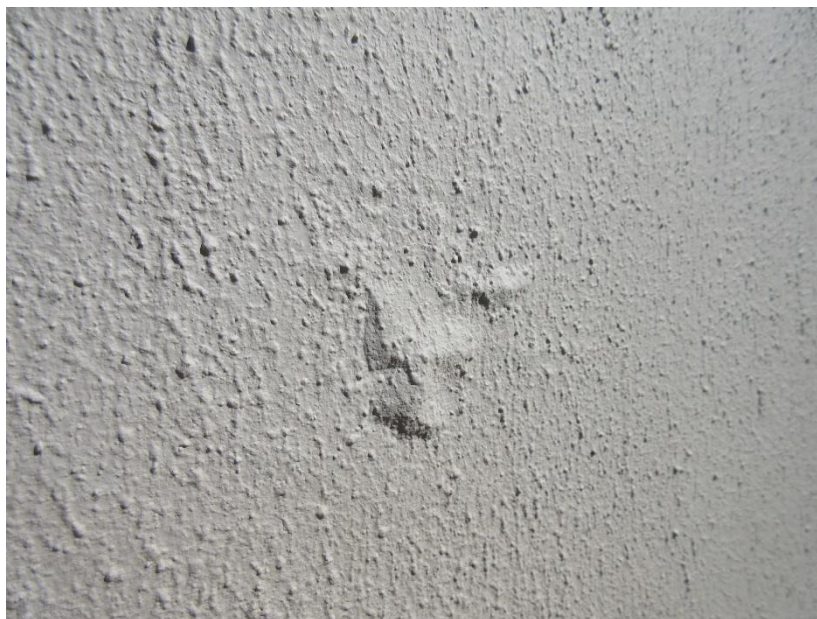
- The Building Consultant made use of a Proti-meter, that is an electronic moisture detecting device, and the moisture content readings in this wall at time of this inspection were at the maximum scale in the red zone on the instrument, thereby confirming an excessively high moisture content in this wall.

Evidence of paint bubbling and flaking on the wall surface due to high moisture content in the wall.

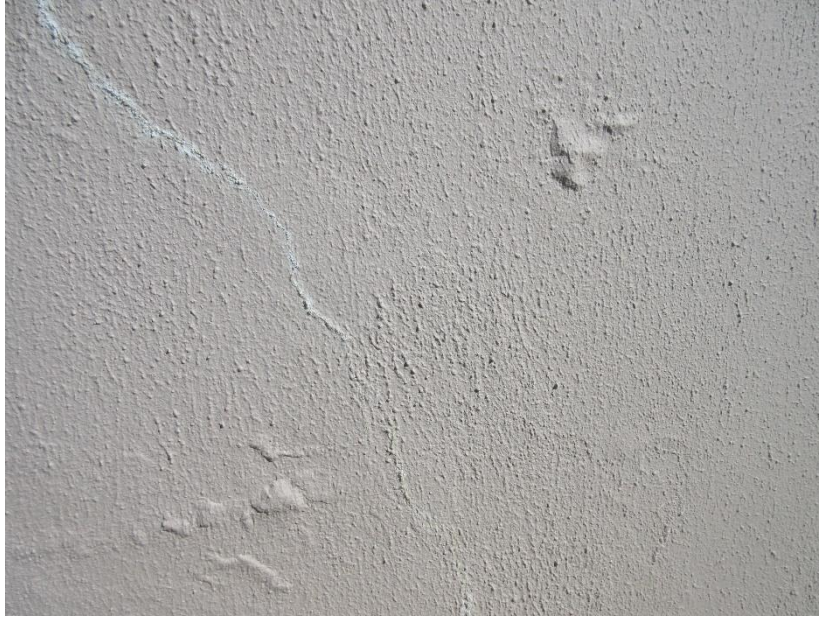
Evidence of moisture causing the paint surface to delaminate; evidence of cracks; evidence of poor repair work to the plaster band at the top of the wall.

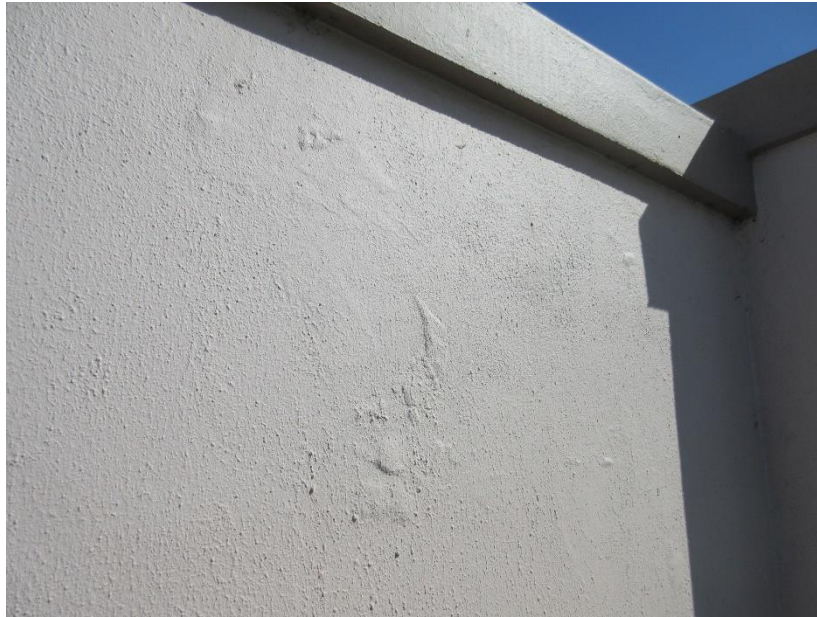
- Also, where the attached brick piers are located, there is a crack forming between the attached pier and the wall, which has not been fixed. [Refer to photograph below].

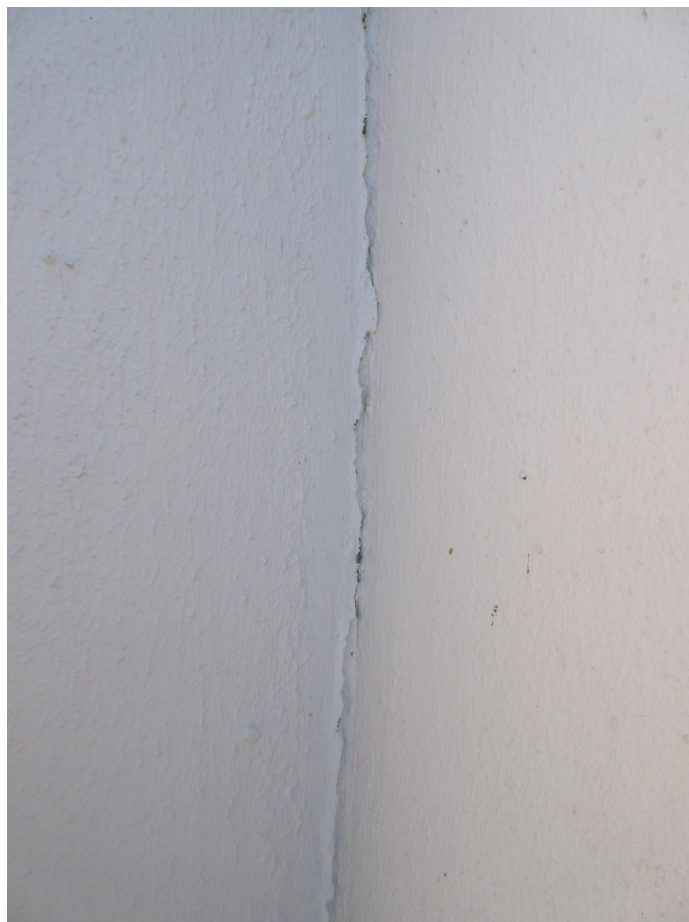
Evidence of a crack reoccurring between two wall surfaces.

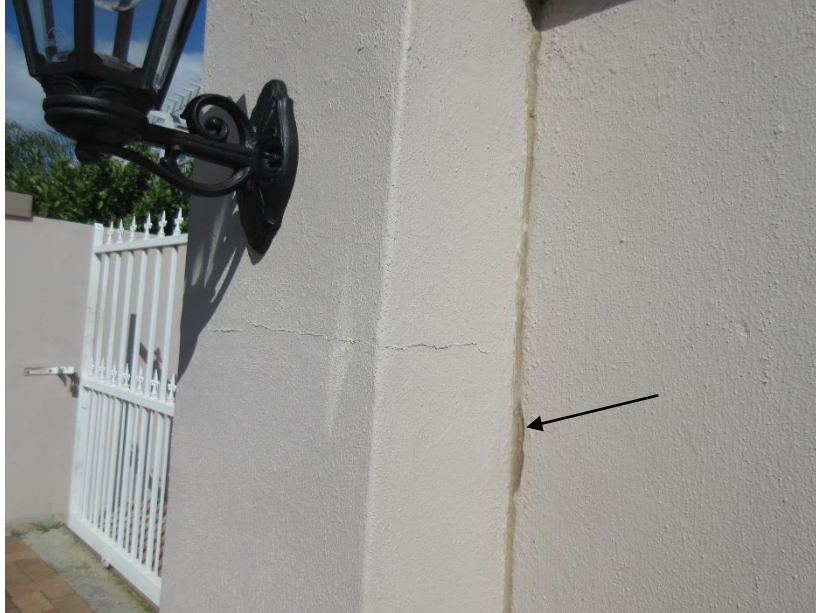
- The Contractor allegedly used Sikaflex flexible sealant between one of the attached brick piers in the wall, however, this is most unsightly and the horizontal crack in the brick pier was supposed to be fixed, but as one can see from the photograph below, has not been fixed.

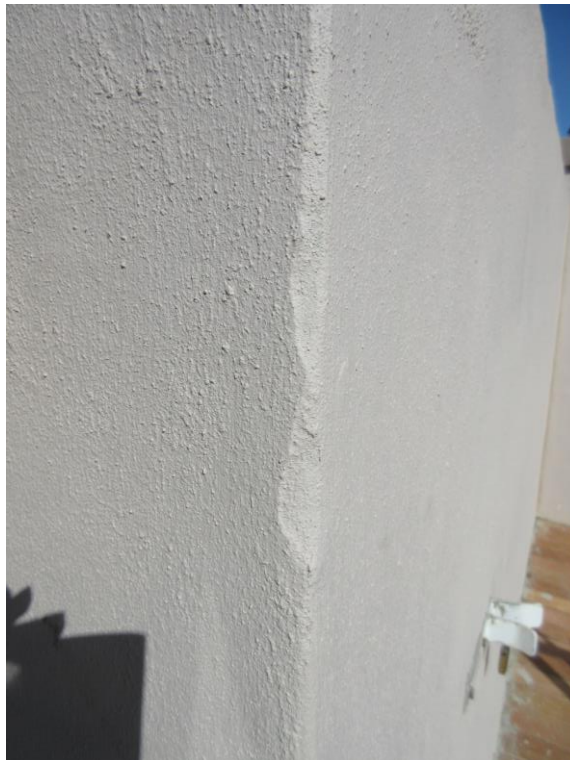
- At the property corner in the Southern corner, at the sliding gate, the Aris has just simply been painted over although it was not repaired. [Refer to photograph below].

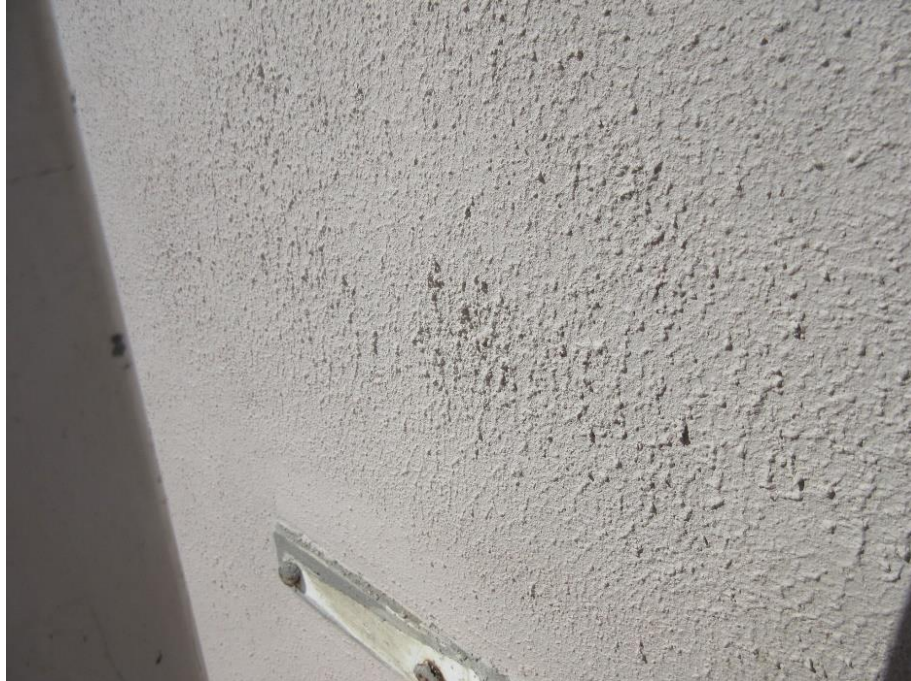
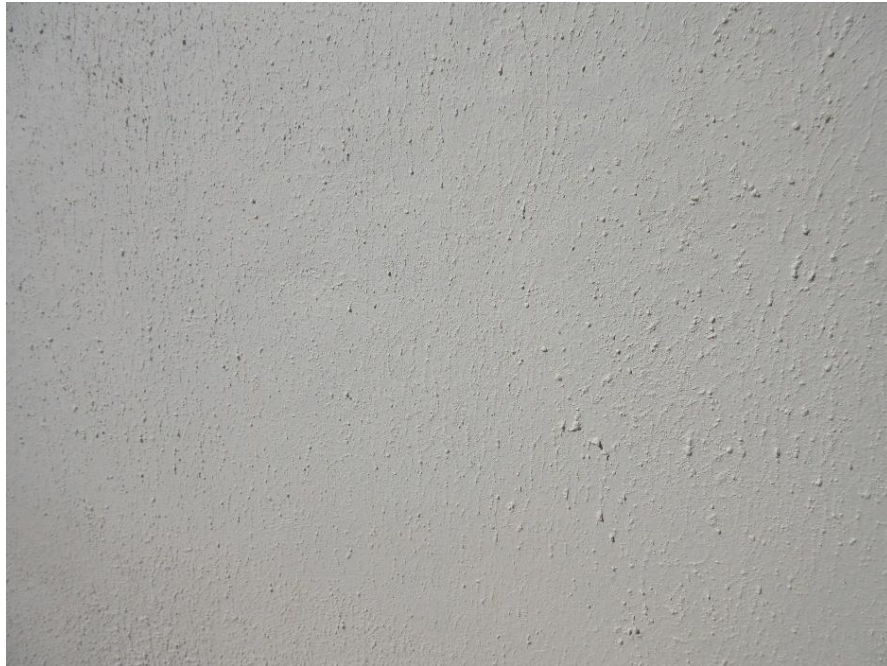
- In places the paint work is relatively smooth; in other places it is quite excessively textured and there is no uniformity between the finishes. [Refer to photographs below]

The top photograph shows very heavy textured wall finish, whereas the bottom photograph is almost smooth.

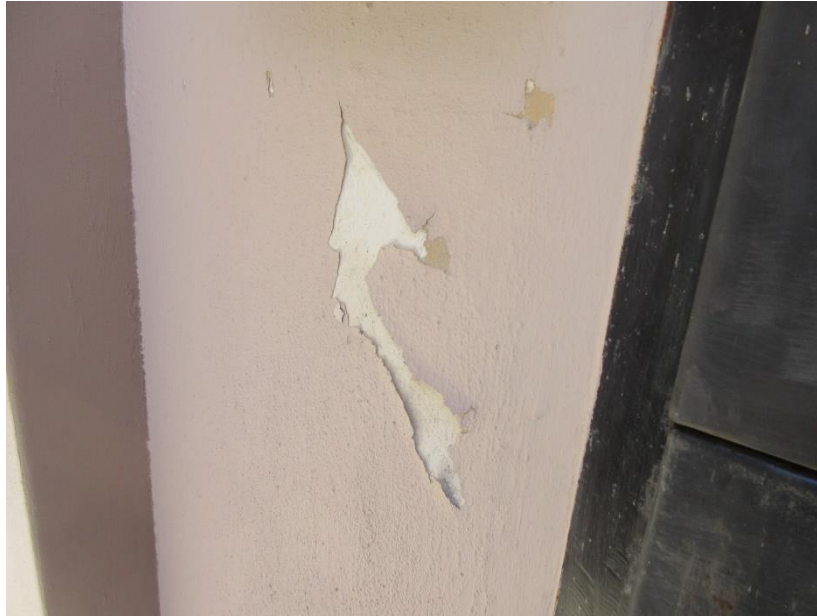
- The walls in the vicinity of the braai have been painted, however, there is no visible evidence of any primer having been used and the Building Consultant comes to this conclusion by the evidence of the paint delaminating and peeling off. [Refer to photographs below]

Evidence of paint peeling off at the braai area.

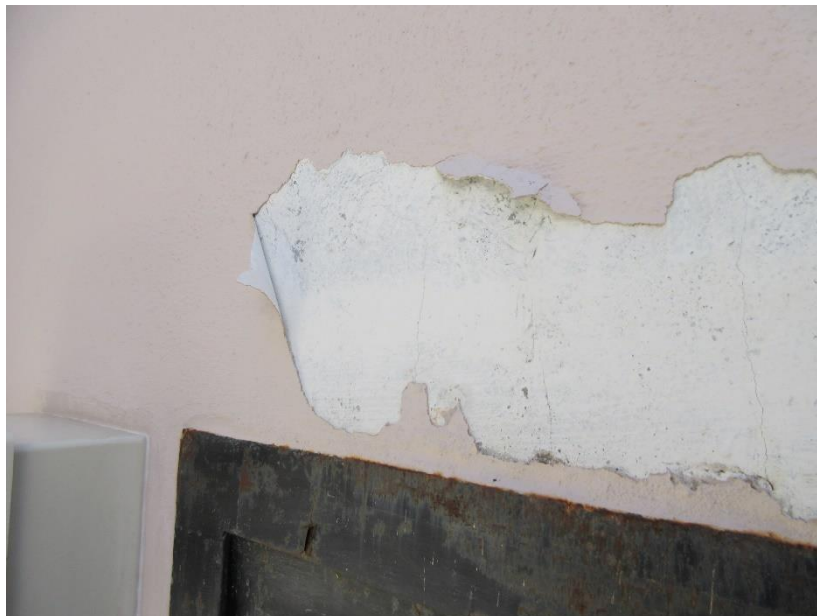
Where this paint has peeled off, there is a powdery surface on the wall.

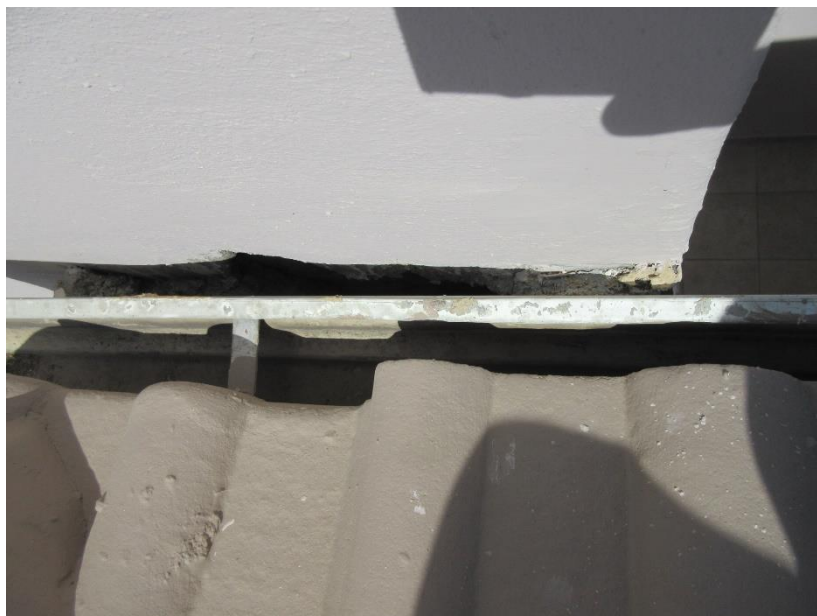
- The rain water gutter from the pitched roof runs parallel to the side of the braai chimney and there ought to be a flashing and counter flashing installed on that side of the chimney and discharging water into the adjacent rain water gutter, so that water does not accumulate underneath the gutter and cause the walls to become damp. [Refer to photograph below].

There ought to be a flashing between the side of the chimney and the rain water gutter.

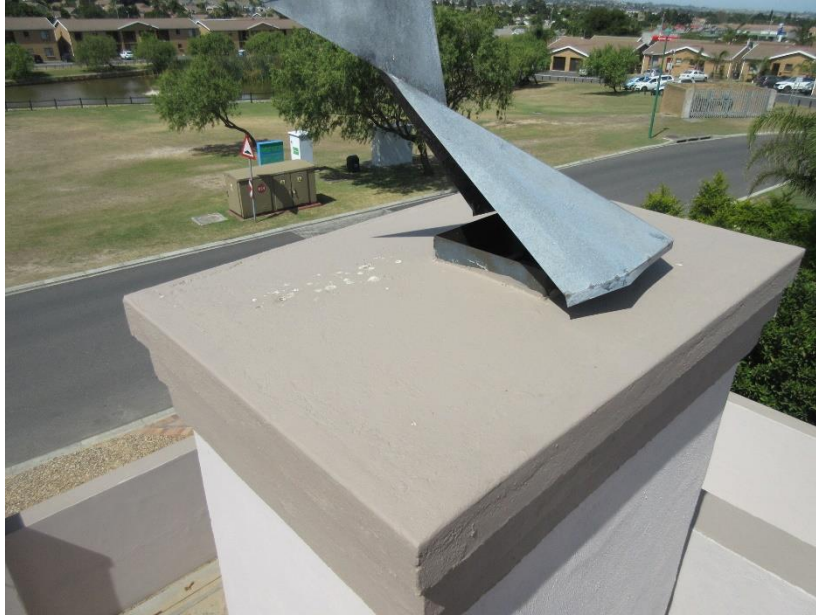
This chimney does not seem to have received a waterproof membrane on top.

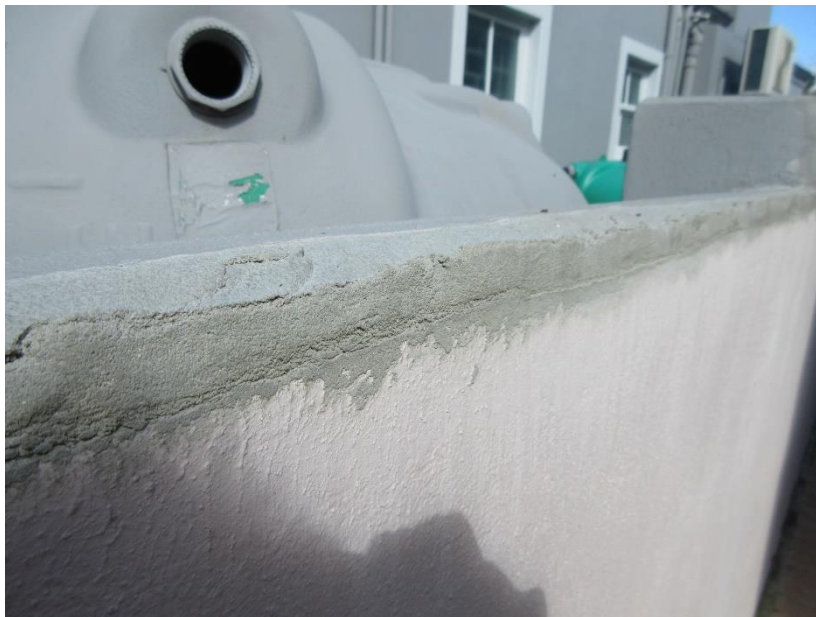
- This wall has been worked on, but one can see from the quality of the plaster work that this work must surely have been undertaken by an unskilled worker and not by an artisan and there surely cannot have been any competent supervision when this work was carried out. [Refer to photograph below].

Evidence of very poor quality plaster work.

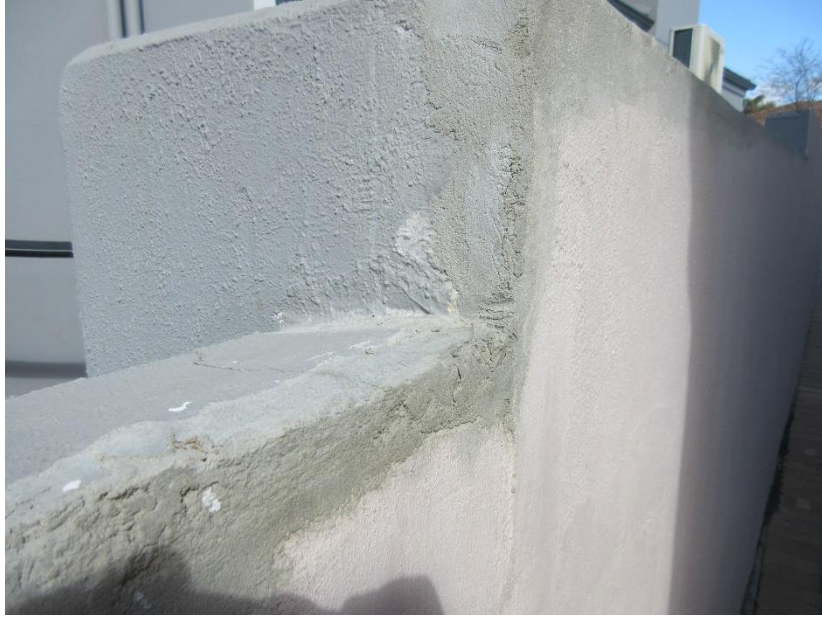
Further evidence of very poor quality and inferior plaster work.

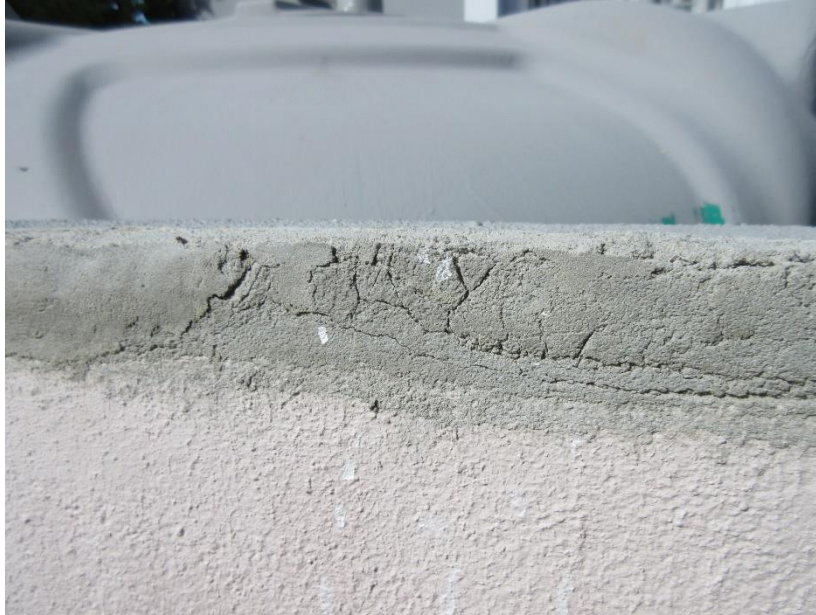
Further evidence of very poor quality and inferior plaster work.

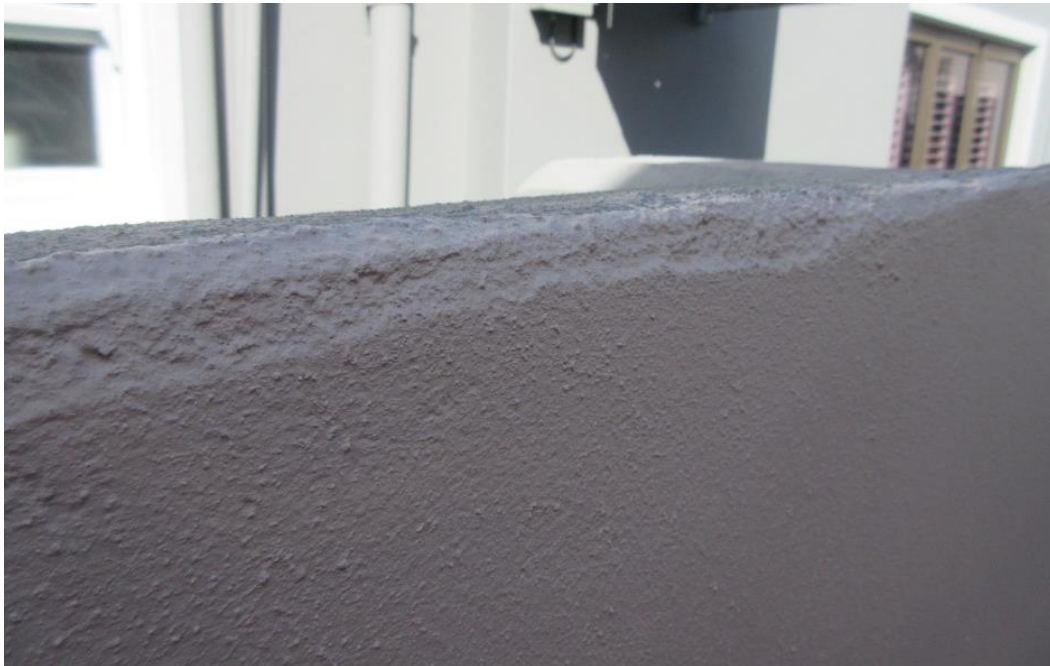
- One can also see how there has been virtually no preparation and has simply been painted over uneven surfaces. [Refer to photographs below]

This wall has been painted even though the plaster work is incomplete.

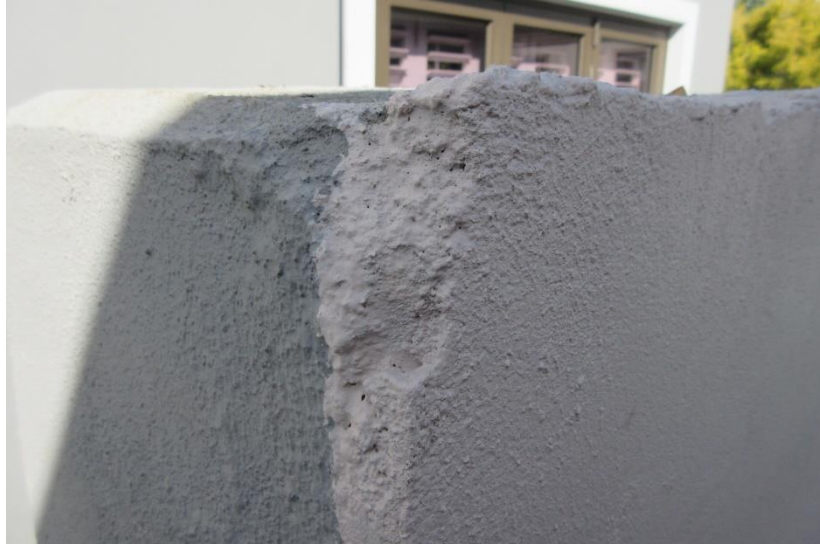
Further evidence of completely unsatisfactory workmanship.

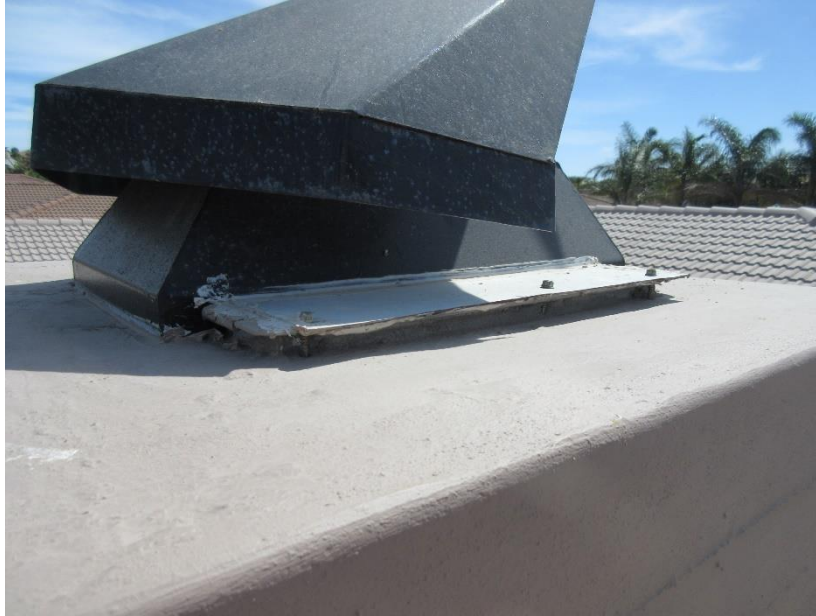
- On the top of the chimney where the metal cowl is fixed, this has not been sealed over and wind driven rain may be able to ingress in this location. [Refer to photographs below].

No evidence of a waterproof membrane on top of this chimney to prevent water from being able to ingress.

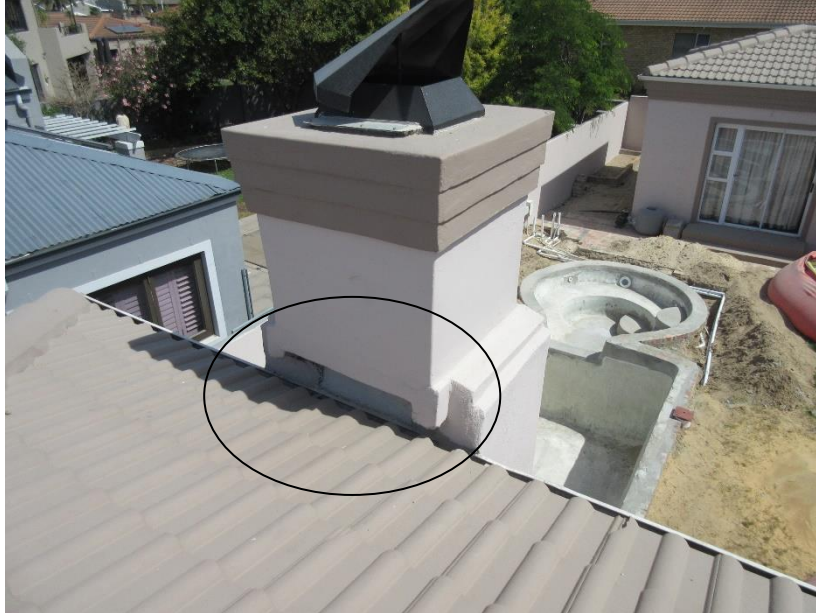
- The back side of the chimney, being on the South East side has not been finished off at all and needs to be properly finished off. [Refer to photographs below].

The back side of this chimney has not been finished off as is clearly depicted in the photographs.

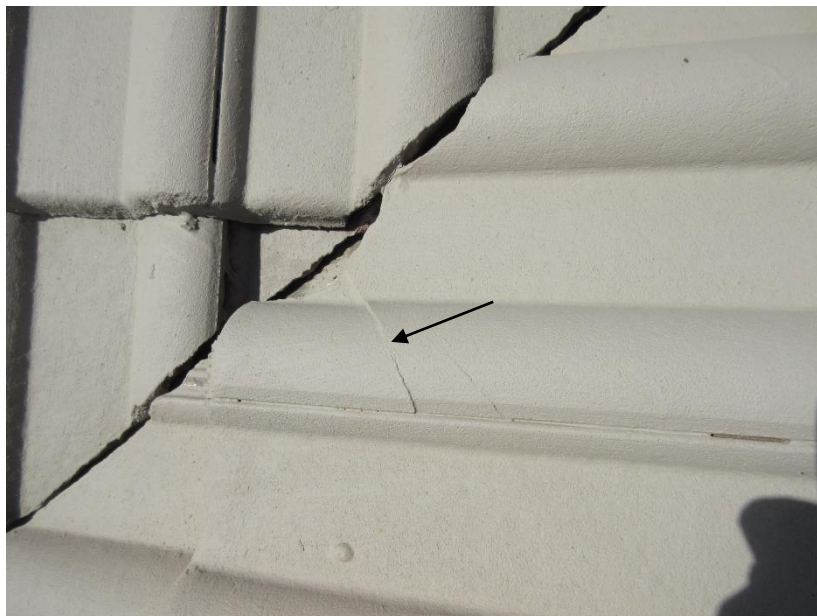
- The existing roof covering was also painted by Messrs Sealtek and there is evidence that they have painted over cracked, chipped and broken tiles and have simply applied an acrylic membrane over some broken roof tiles.
- These damaged roof tiles ought to have been replaced with new prior to applying roof paint there over.

A cracked tile that has simply been painted over.

The roof work is also defective, in that paint has been applied over cracked, chipped and damaged roof tiles.

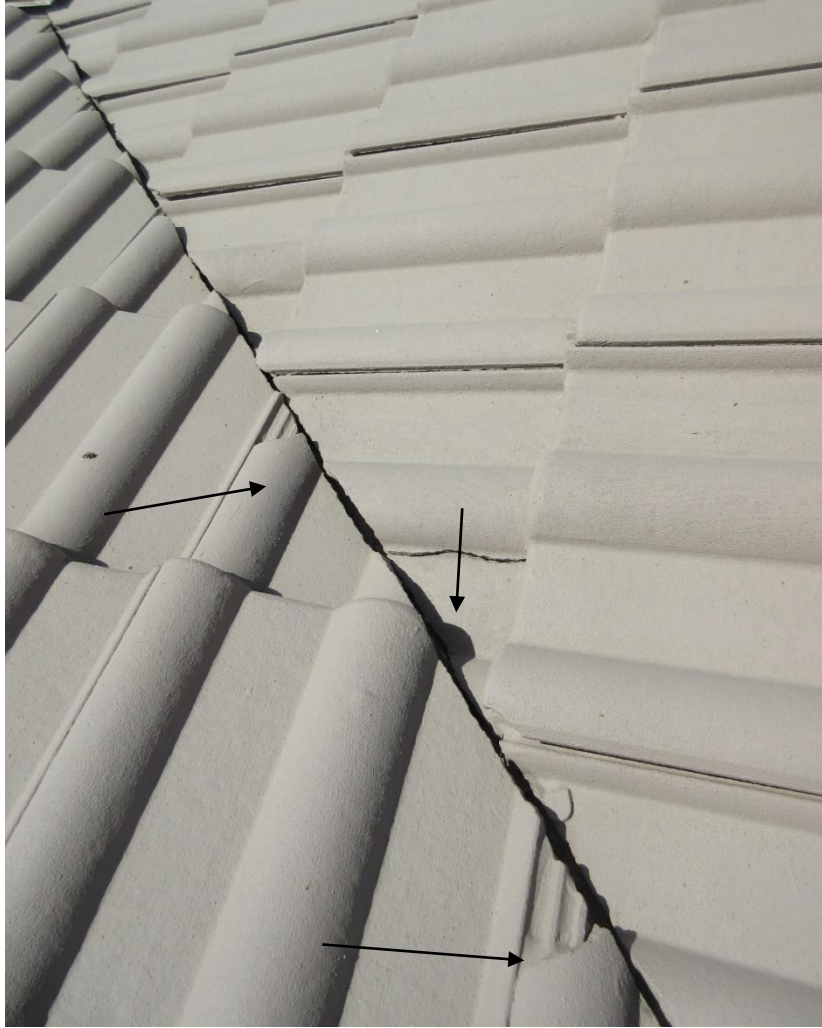
More cracked and broken tiles that have simply been painted over.

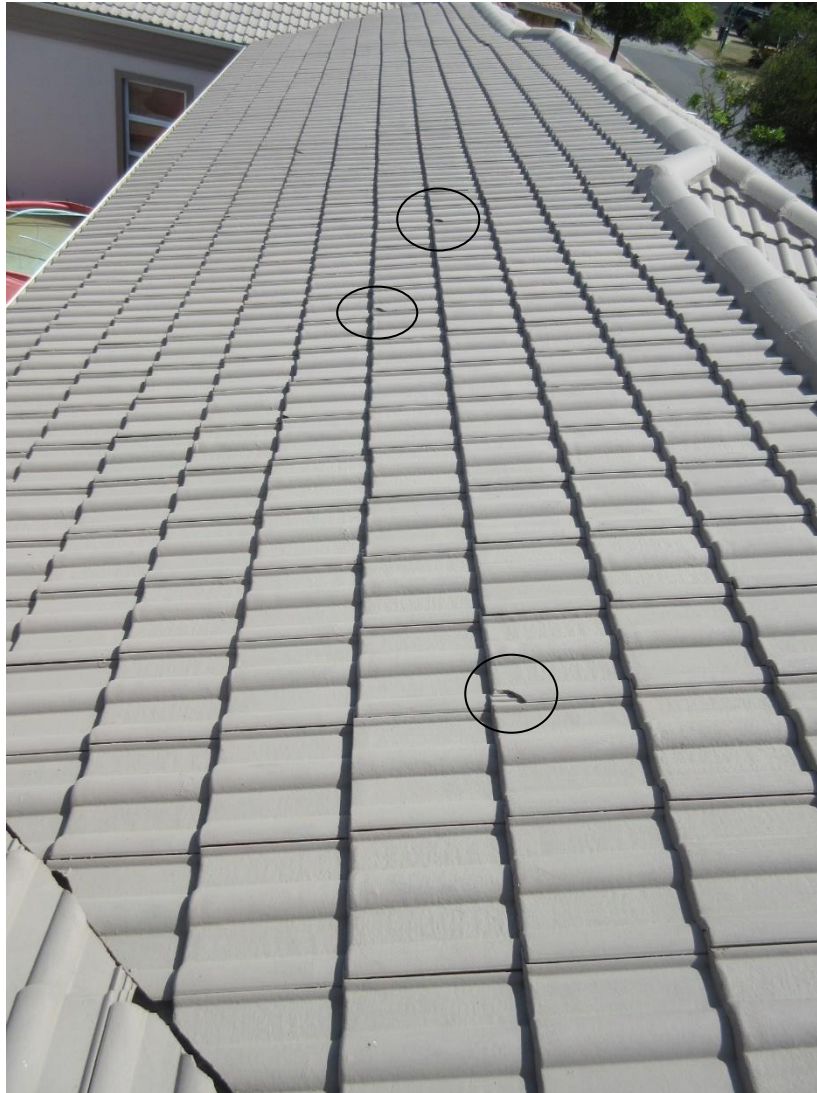
More cracked and broken tiles that have simply been painted over.

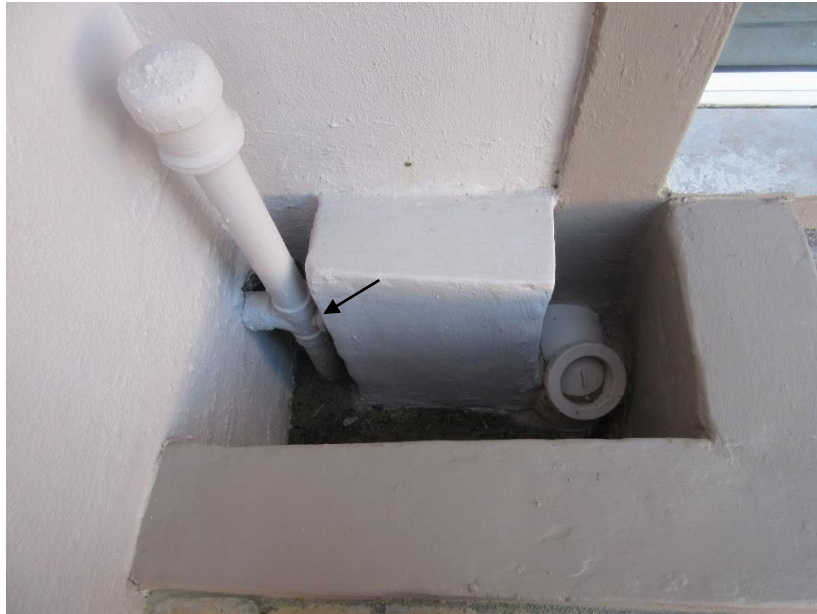
- In the Eastern corner of the swimming pool area, the Contractor lowered the ground level so that one could access the cleaning eyes of the pipes, however, one still cannot access these cleaning eyes properly. Also, there is no cover over this facility.

How does one gain access to this waste pipe?

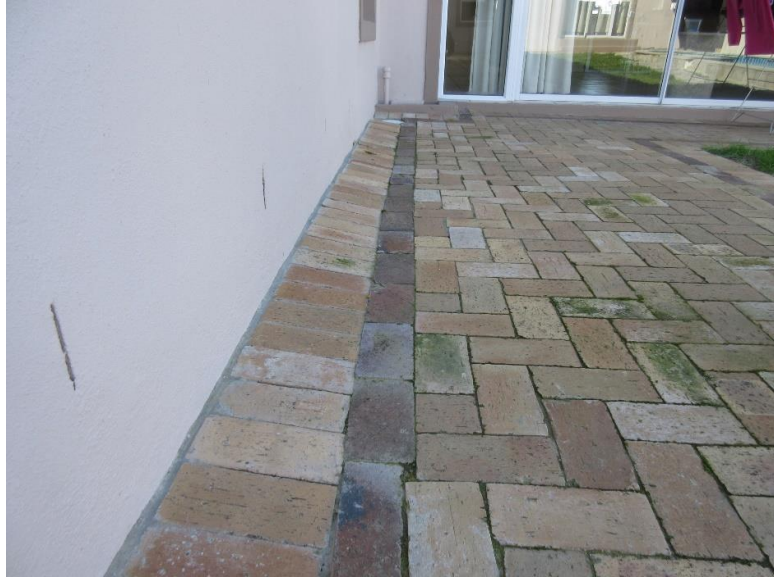
- The brick paving on the South Western side of the house, in the vicinity of the swimming pool, was lifted and re-laid by the Contractor, however, the header course against the house is substantially out of level and one cannot now place furniture in this location. [Refer to photograph overleaf]

**The header course against the wall is completely out of level;
no proper grouting to the remainder of the brick paving.**

13. That the brick paving be carefully lifted; the bricks be cleaned and this area to be re-laid in a proper and workmanlike manner, ensuring that the paving bricks are properly grouted.
14. That all remedial work be undertaken in a proper and workmanlike manner, and all in compliance with Occupational Health and Safety Act Regulations.
15. That remedial work only be undertaken by appointment with Mrs Sonet Fitchat, so as to cause as little inconvenience and disruption as possible.
16. That adequate precaution be taken whilst executing remedial work so as to prevent any consequential damages from occurring.
17. That all work be under competent and consistent supervision.
18. That the premises be left in a clean and tidy state upon completion.

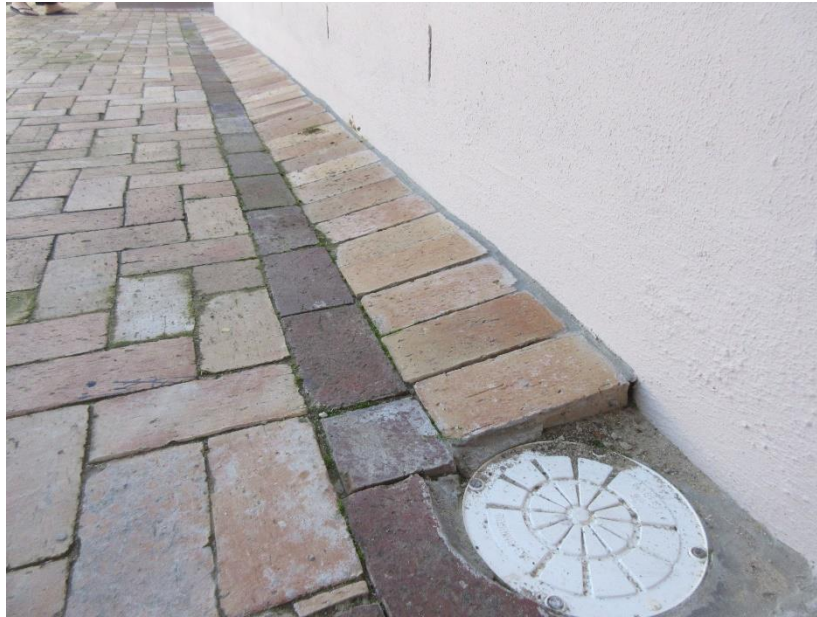
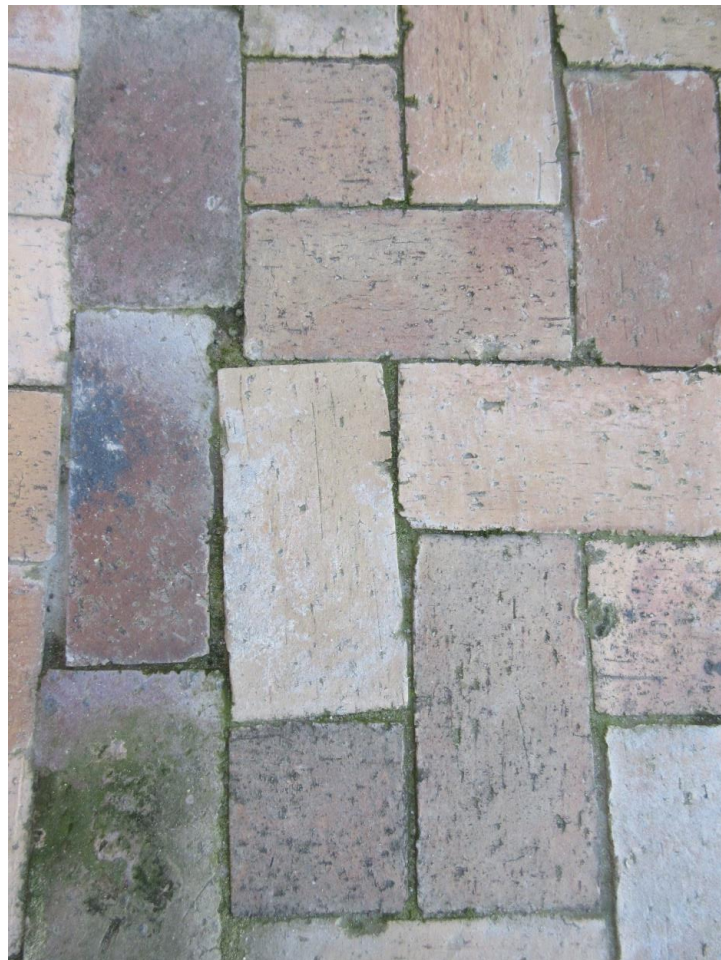
Evidence of very poor quality brickpaving with cut bricks and wide gaps between bricks.

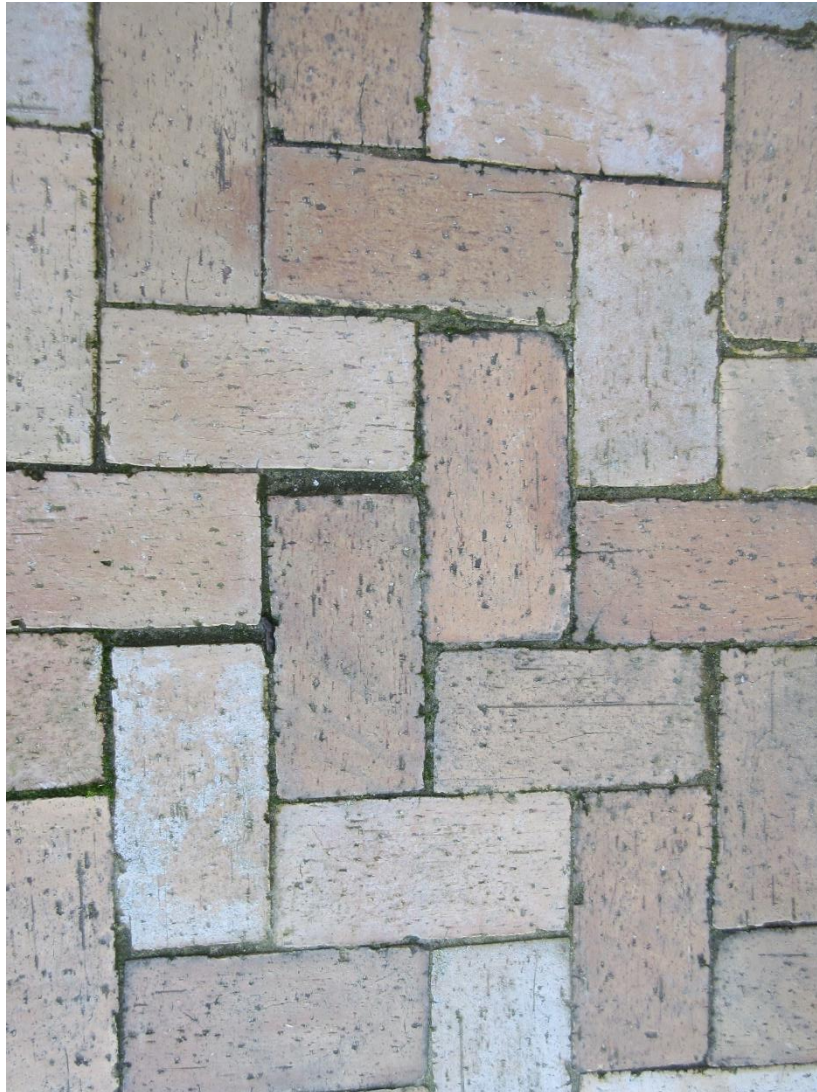
- The quality of the brick paving leaves much to be desired with several bricks being skew; bricks that are soiled and little evidence of any grout.

- The sloping header course is also evident on the North Western side of this area.

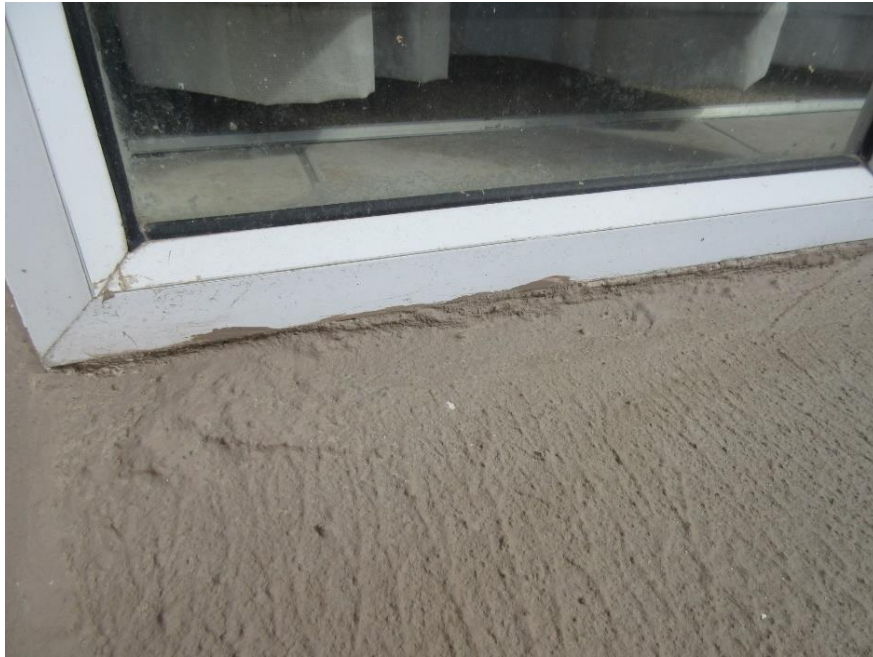
- Where the steps have been constructed, the material that has been used to coat these steps has been smeared onto the white epoxy coated window frame. [Refer to photograph overleaf]

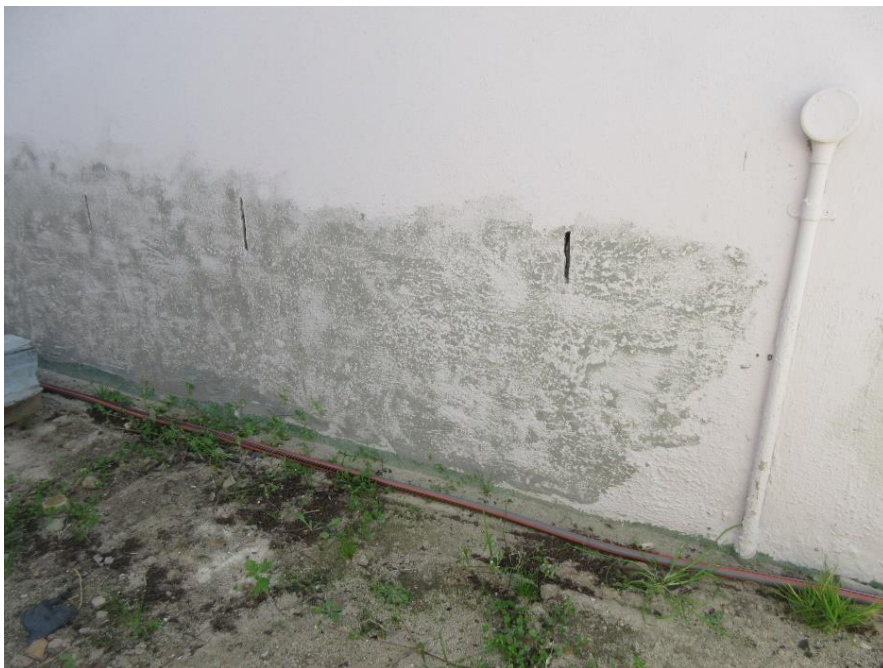
- One can see from the photograph below that the wall has not been properly painted on this elevation.

**Is this meant to be a finished product?
Is the Employer meant to accept this quality of workmanship?**
