IN THE MAGISTRATE'S COURT FOR THE DISTRICT OF **KUILS RIVER**

Case No: 863/2020

No. 43 - Notice to Third Party

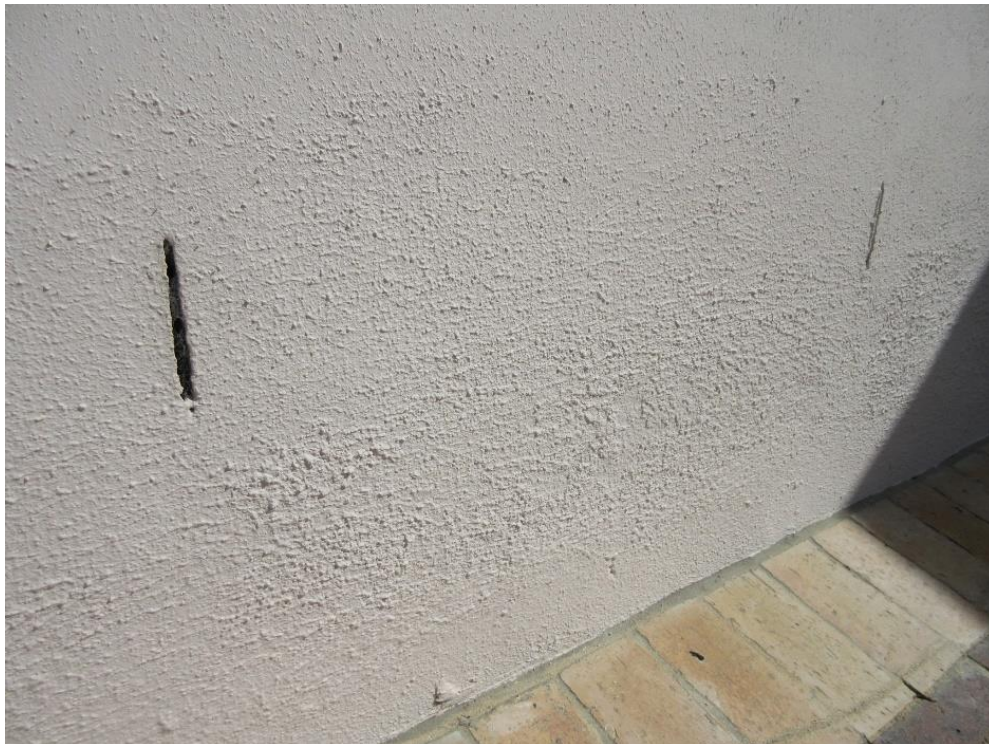
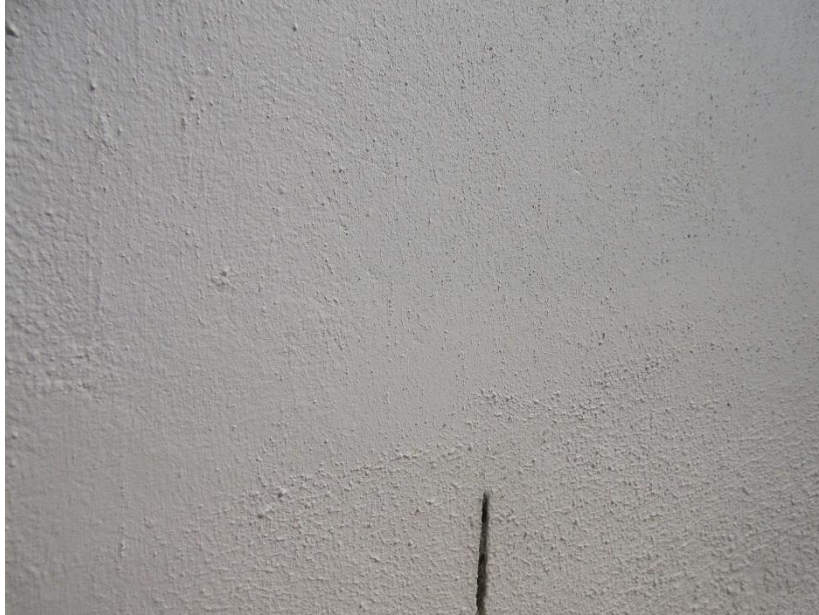
- On inspecting the wall, being the South East elevation of the office, one can very clearly see on this wall, several different textures. [Refer to photographs below]

- These range from a very rough stipple; to relatively smooth with a couple of speckles to a reasonably textured coating.
